Feasibility Study for a Pavilion at the Duke Park Bathhouse

Owner: City of Durham

Architect: RND Architects PA

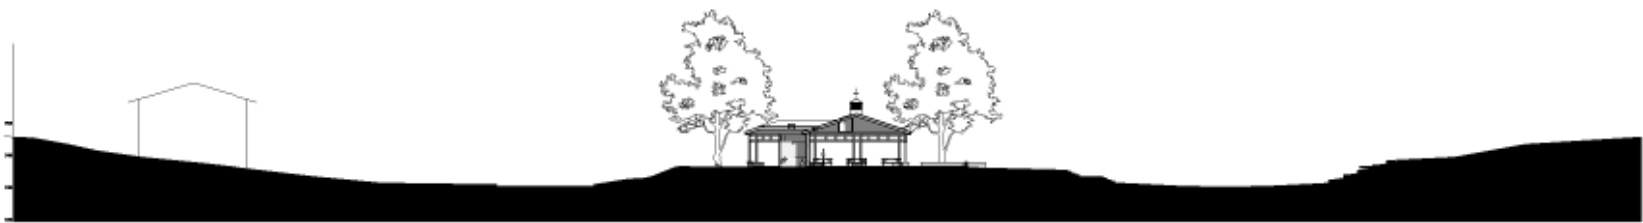
6 **Site Section**
1" = 60'-0"

The Site Section diagram illustrates the new pavilion's height and distance in relation to the nearest private residence and in relation to the meadow and opposing hillside in the park.

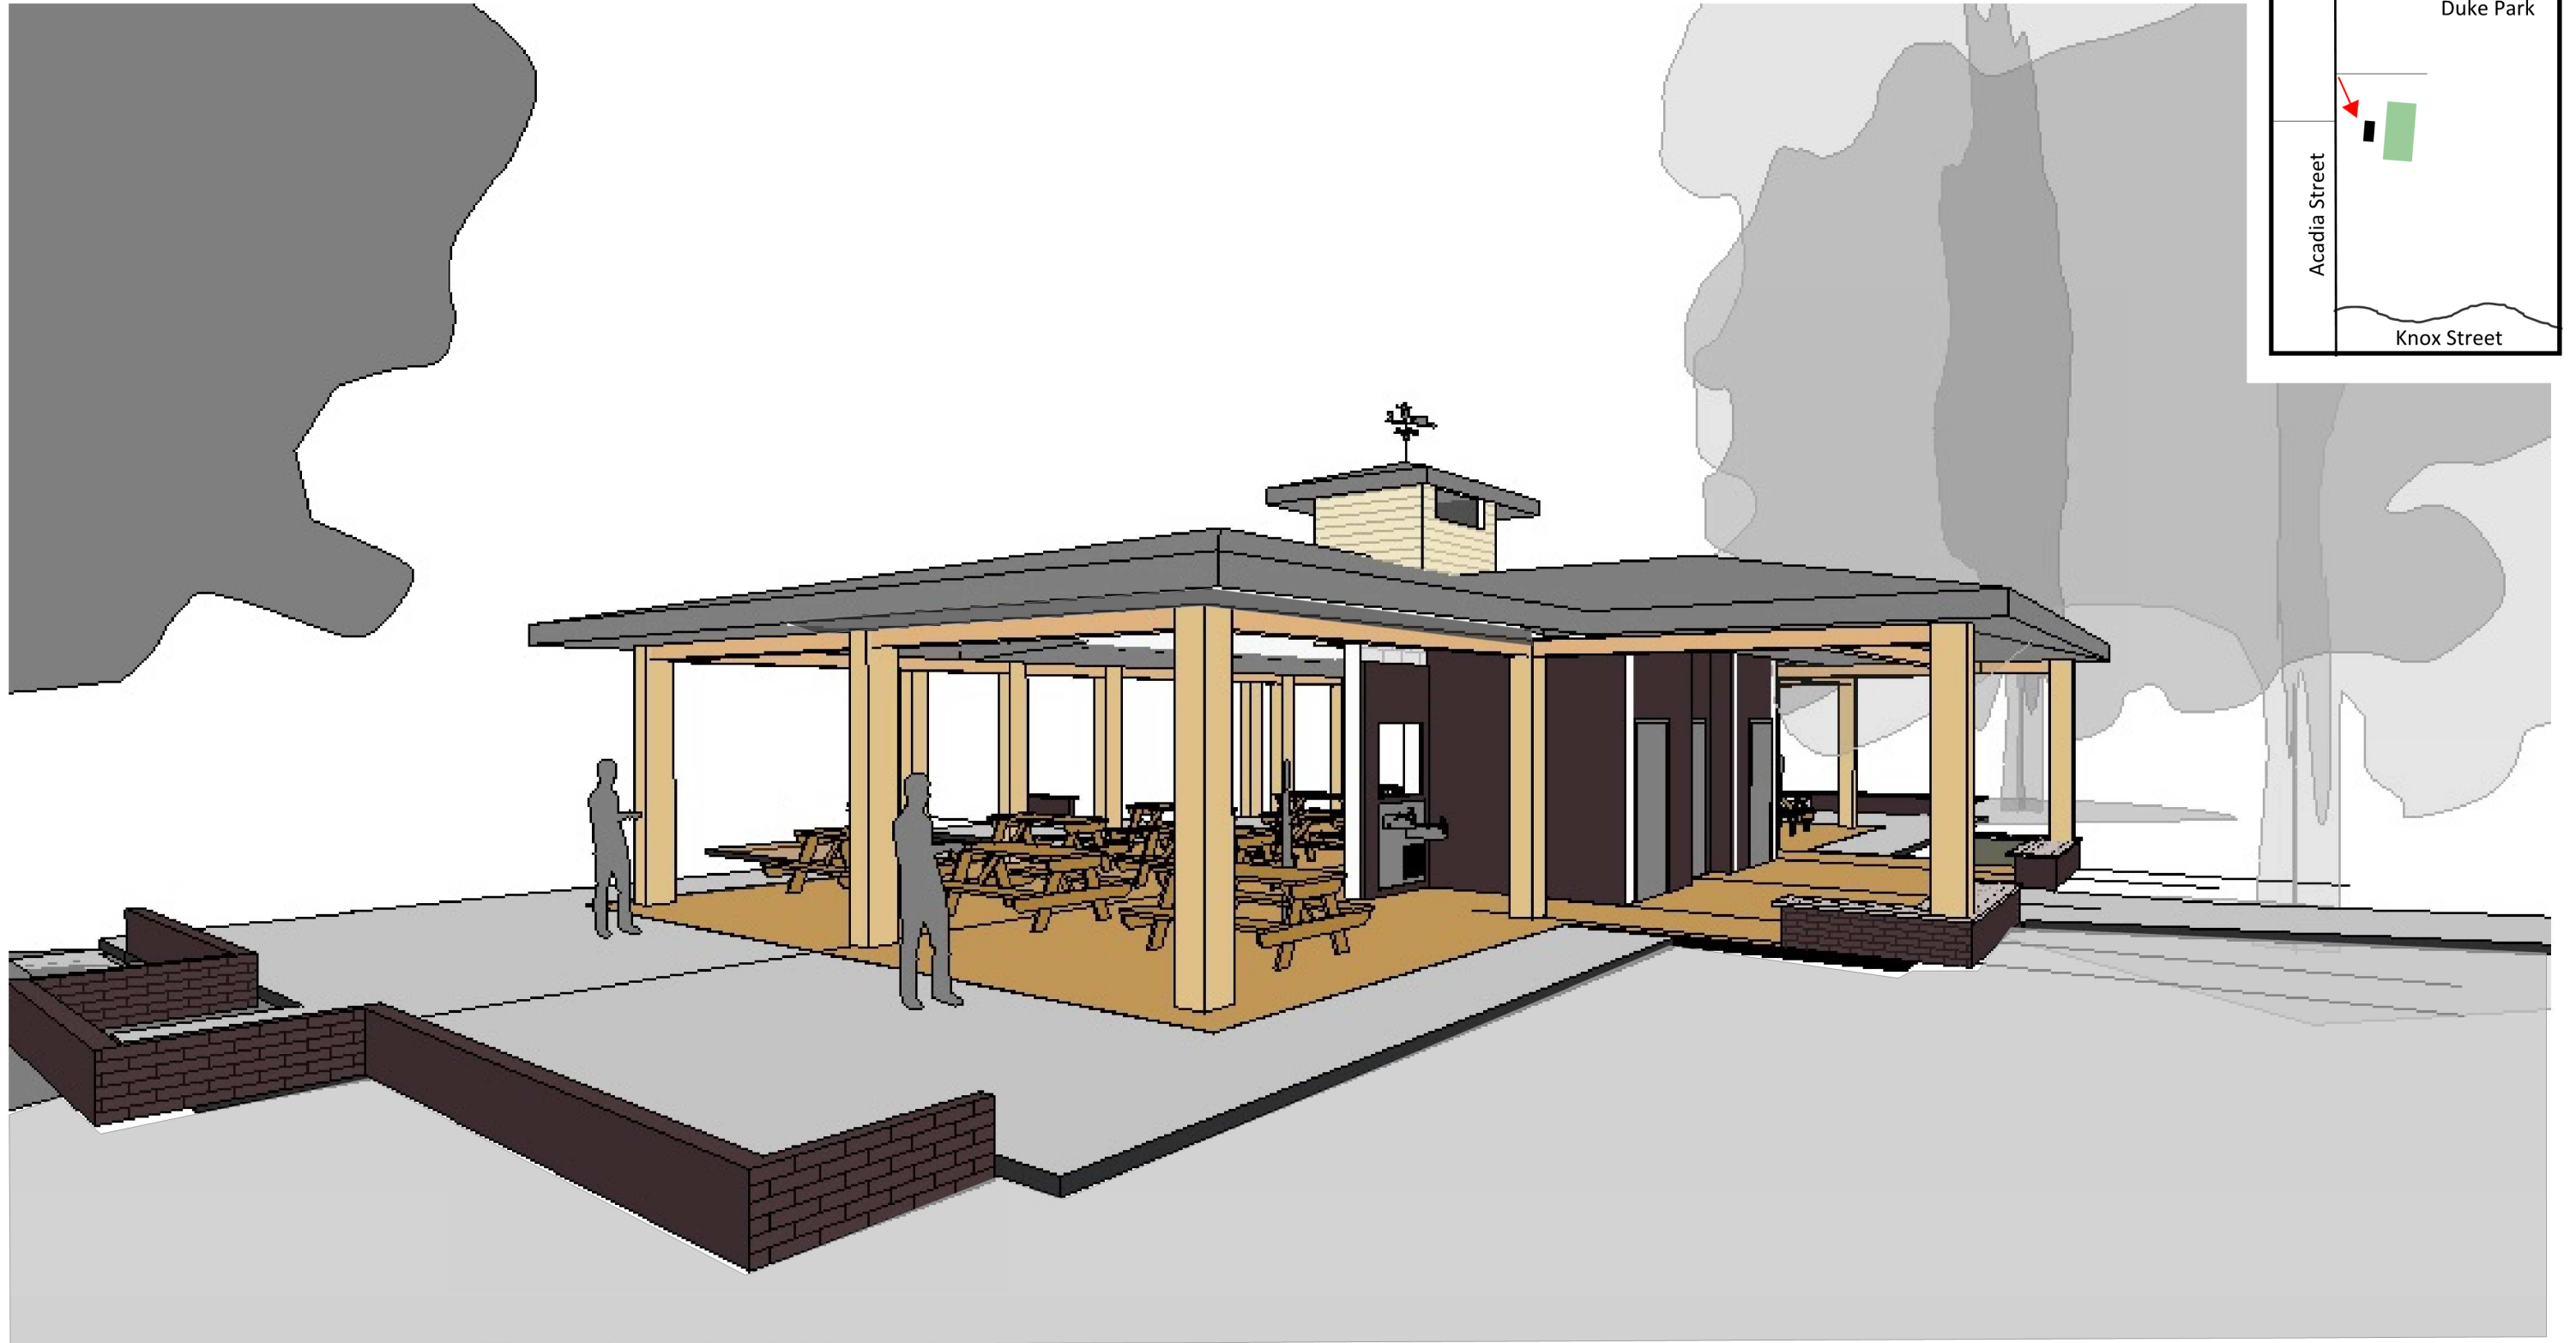
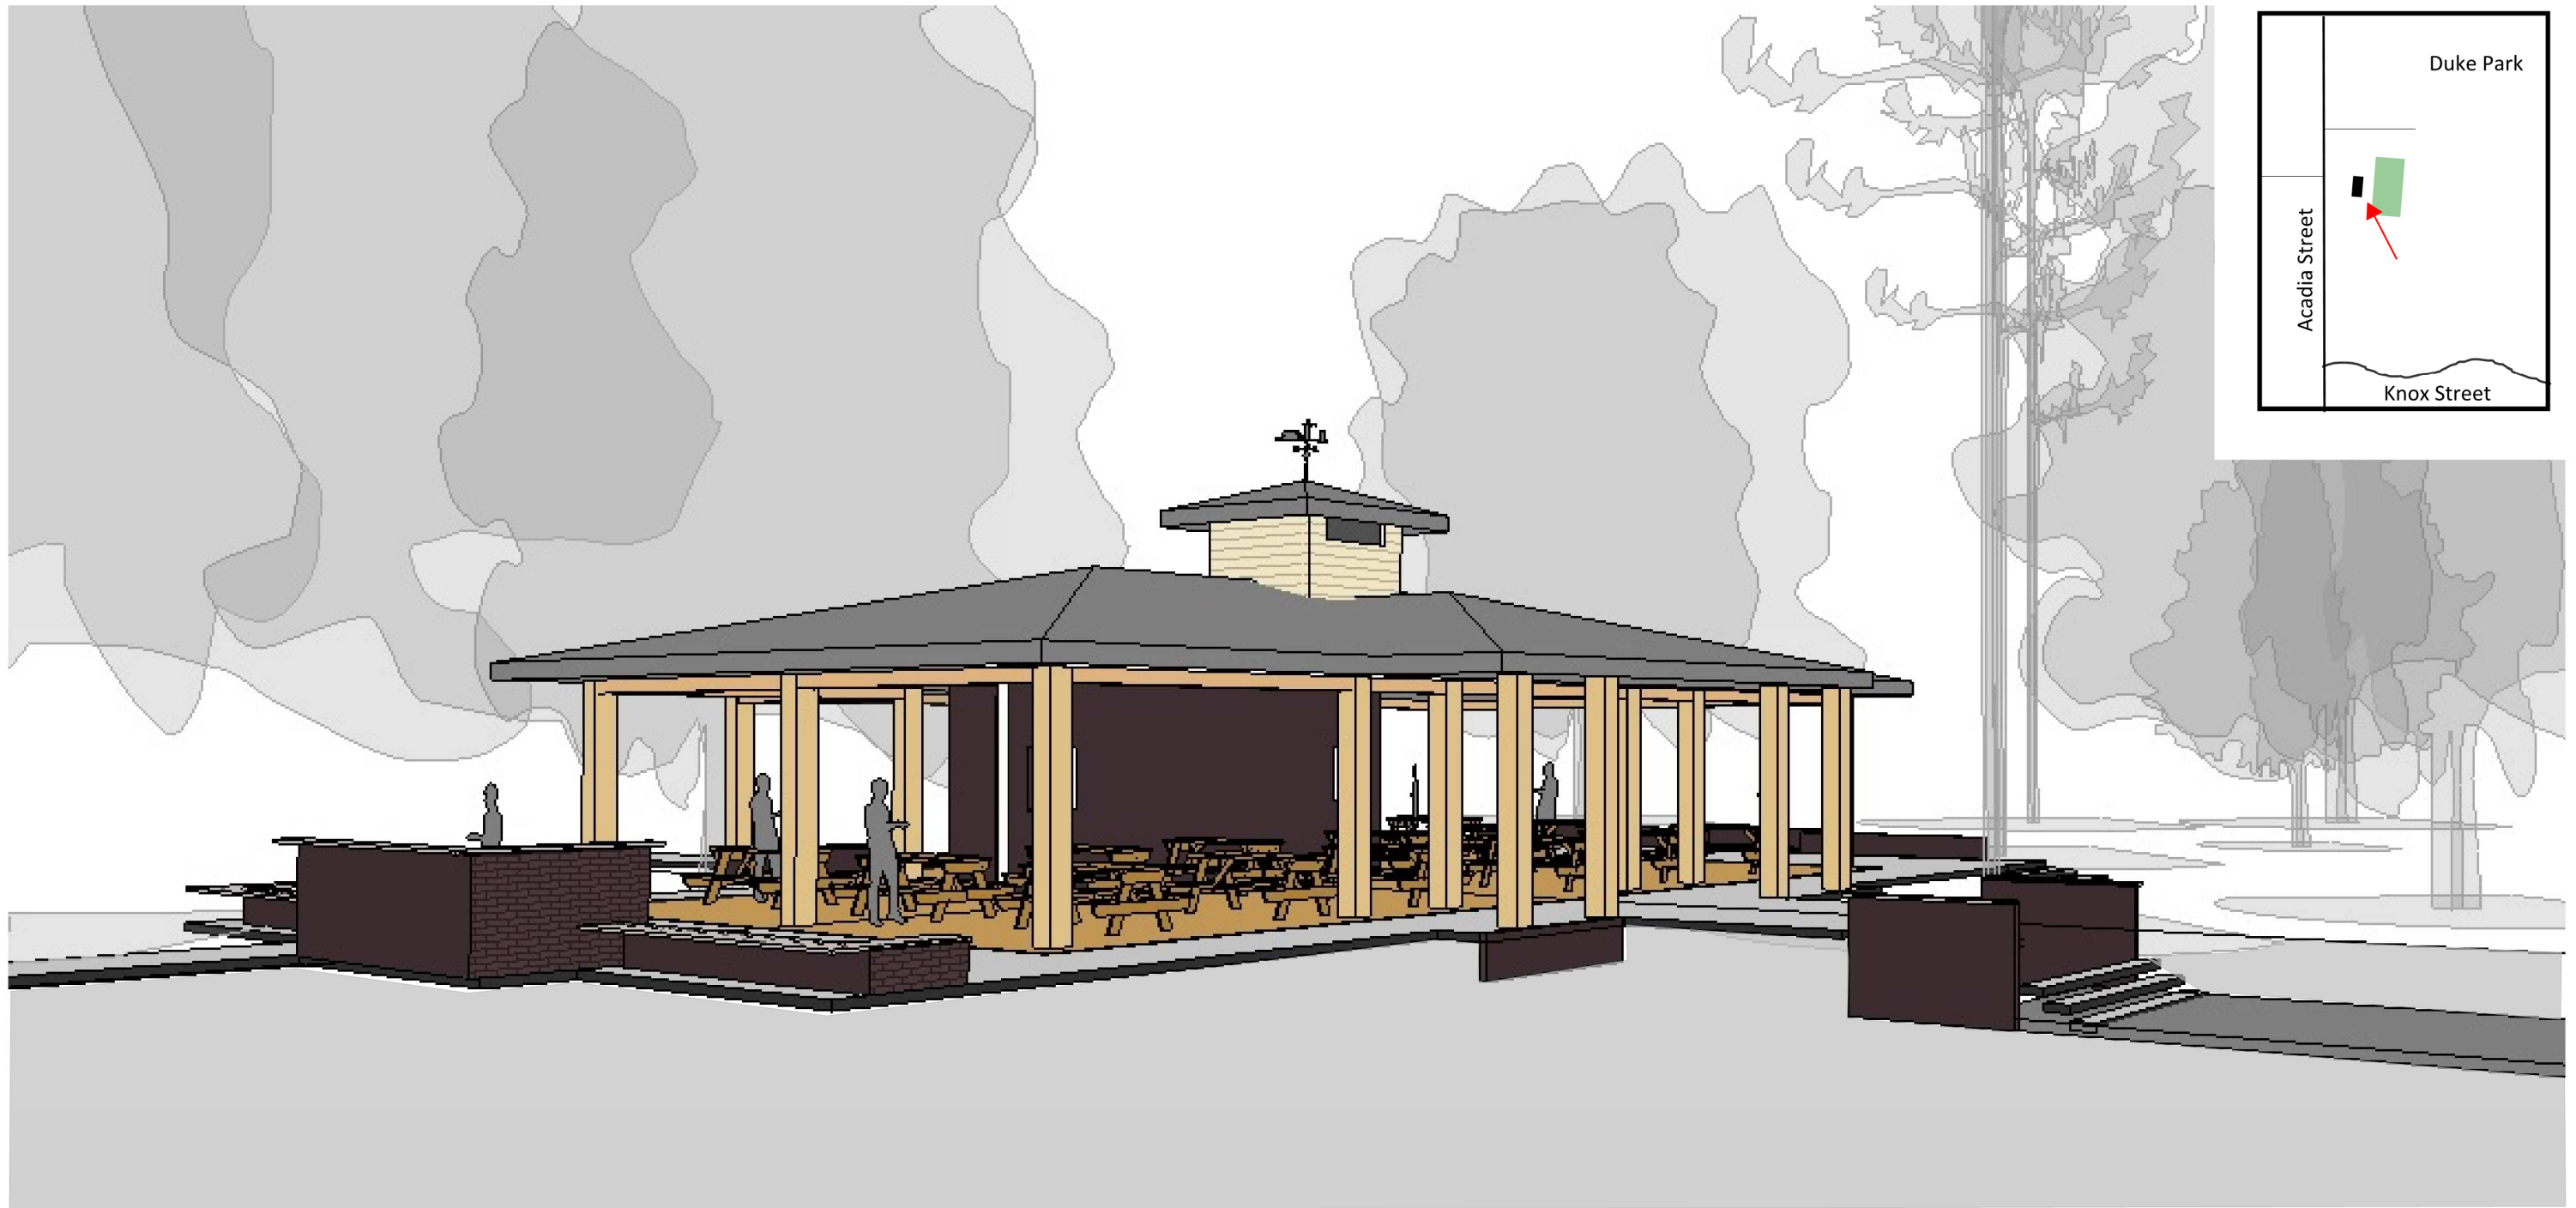
Concept C

The first rendering depicts a view east of the existing southern approach to the bathhouse. The east stage areas is shown with the free standing stone wall with the large square openings that reference the former square openings in the bathhouse. Park history plaques would be mounted on this wall and electrical outlets would be integrated wall recesses. The bulletin board for park and neighborhood information would be located on the west exterior wall of the toilet room building. The second rendering shows a conceptual three dimensional view of the pavilion looking toward the east side of the toilet room wall.
